FOREST PRODUCTS RESEARCH IN PICTURES

NO. 72

**STRONG CORNERS NEEDED EVEN
ON WELL BRACED CRATES**

**FOREST PRODUCTS LABORATORY
U. S. FOREST SERVICE
MADISON, WISCONSIN**

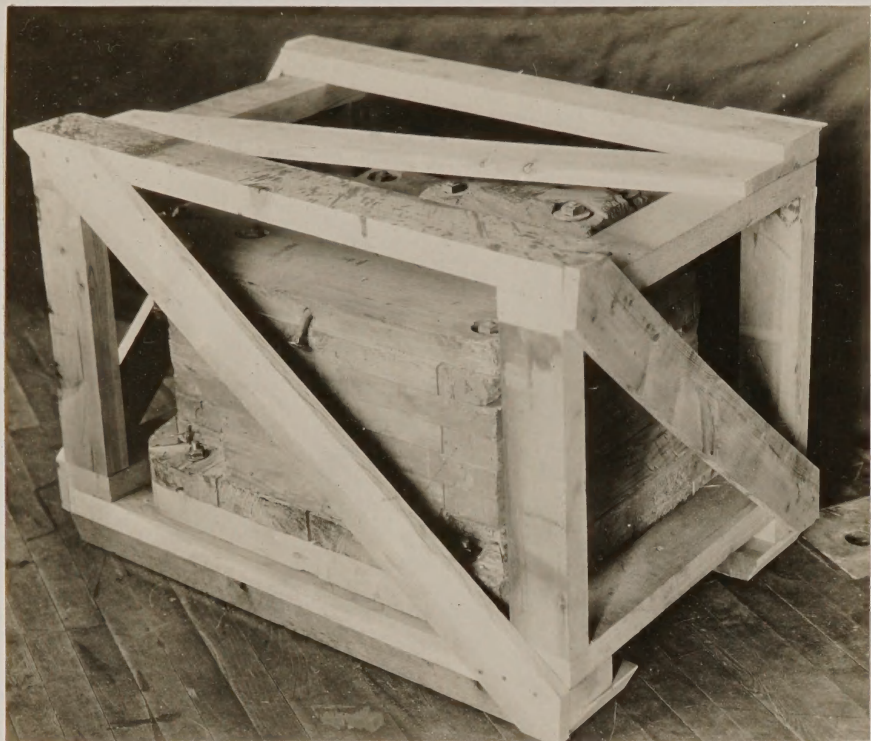
The type of engine crate shown here at the top failed at the corners after an average of only 7 drops in the box testing drum at the Forest Products Laboratory, in spite of having braces on 5 sides and sufficient rigidity in the 600-pound dummy load bolted to the sixth side to make a brace there unnecessary. The crate shown at the bottom carried the same weight of contents as the one above and was braced in the same manner, but its corners were of the "3-way" type with all nails driven into side grain. This type of crate, withstood an average of 62 drops, or nearly 9 times as much rough handling as the other type.
